Intervention Monitoring

Millewa Forest

2016-17

Report Title: Intervention Monitoring in Millewa Forest, 2016-17

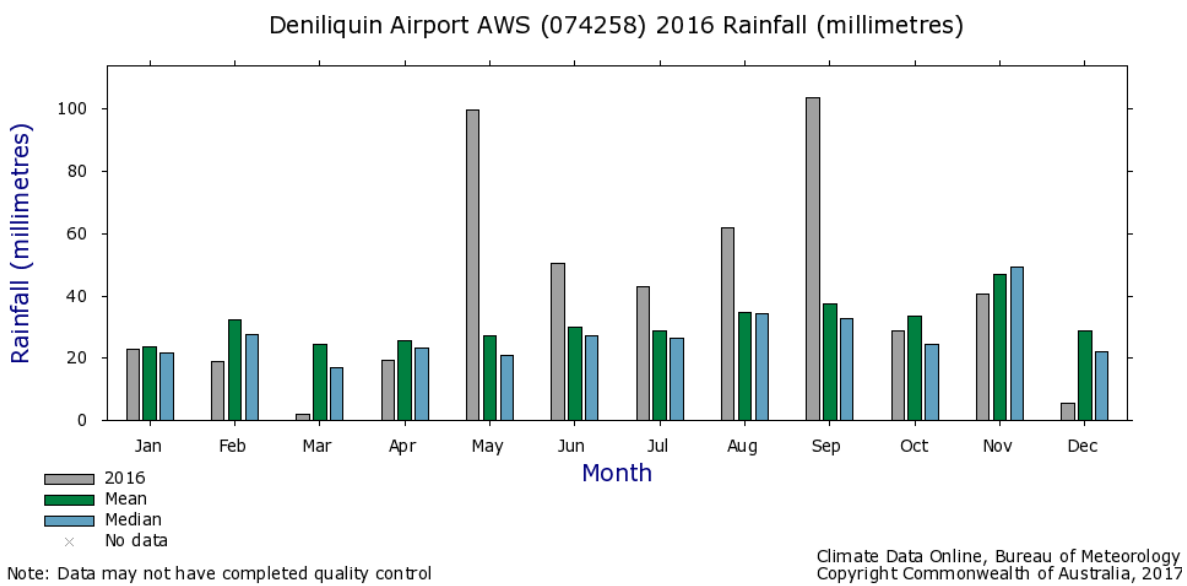
Figure 3: Rainfall recorded at Deniliquin Airport 2016 (BOM, 2017)

2016 experienced higher than average months of rainfall in the region from May to September (Figure 3). September 2016 was the Murray-Darling Basin’s wettest September on record (MDBA, 2017), with the area-averaged rain totalling 249% over the long term monthly mean (Figure 4). The wet weather conditions, which began in May provided high flows throughout the system across winter and early spring. Millewa experienced 187 days of flows exceeding channel capacity. This provided a much needed flush across at least 80% of Millewa’s floodplain and provided long duration flooding across much of the lower floodplain and wetlands. The peak volume discharged from Yarrawonga was 178 GLs (Figure 5).

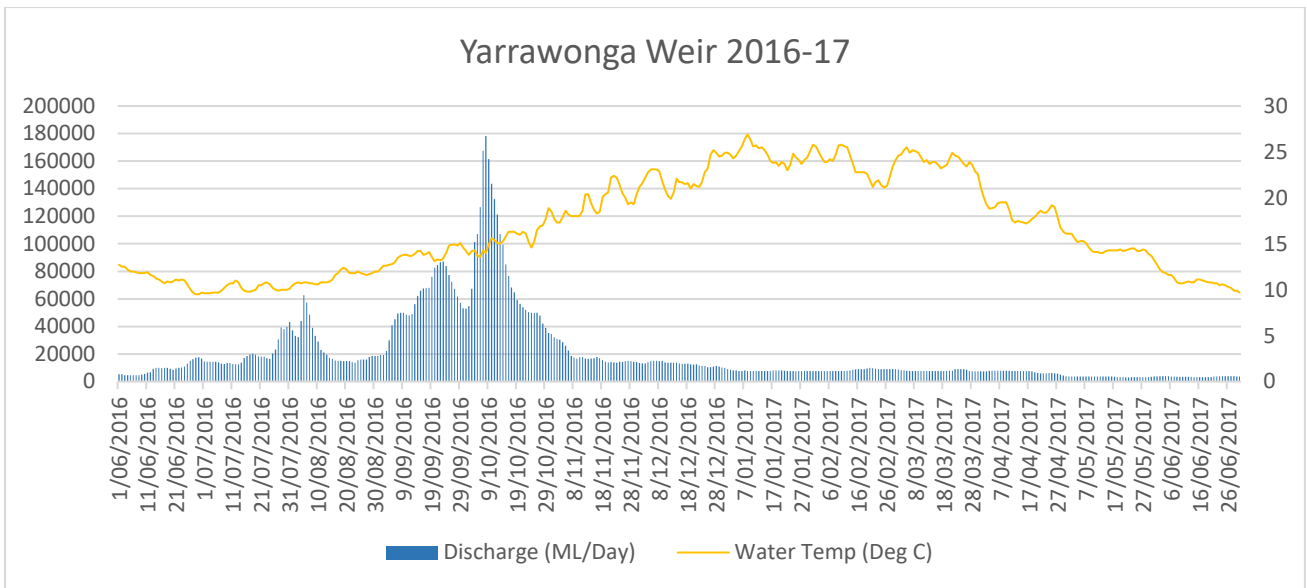
Figure 5: Flows and temperature of water discharged from Yarrowonga year for the 2016-17 water year (data from MDBA River Data, 2016).

Access to sites was limited throughout winter and spring due to widespread floodplain inundation with high rainfall further compromising access to the remaining roads. Depths on the floodplain were recorded using the gauge boards when available, however depths in the peak of the event often exceeded the height of the gauge boards. Dissolved oxygen (DO) levels remained stable throughout early spring with water temperatures not exceeding 20 degrees until mid November (Figure 5).

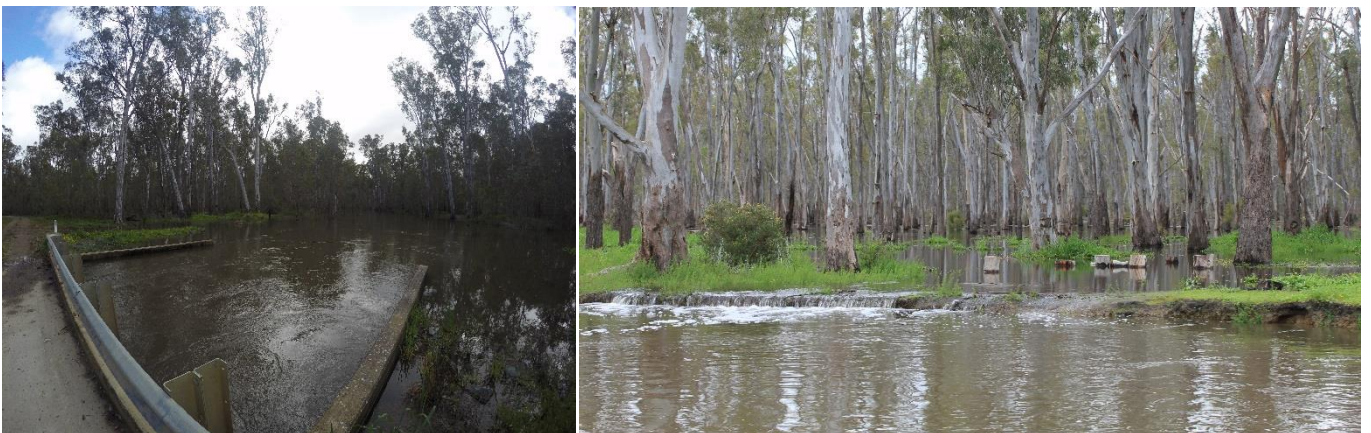
Channel capacity was exceeded in mid- June which prompted all the Murray and Edward regulators to be opened to allow flows to pass through the forest. They remained open until late December when flows dropped below channel capacity (Figure 5). To allow fish passage from the floodplain back into the river and to maintain connectivity within the system, Pinchgut regulator remained open until Autumn, delivering water into the forest via the Toupna creek system. Pinchgut regulator was chosen to be closed last, as it delivers flow into the Toupna system at a velocity which allows large-bodied fish to migrate back out of the Toupna creek system and into the Murray. Murray Cod were sighted moving upstream out of the Pinchgut regulator (pers comms. Jarrod Davies) in March. Cod were also found trapped behind Bunnydigger regulator in the Moira Lake precinct, which prompted the regulator to be re-opened for a short time to allow the fish to move out of the system. Flows were held at a height which aimed to promote connectivity within the creek systems throughout late summer and autumn to continue to allow fish movement.

Figure 6: **Left:** High flows pass through Mary Ada regulator inundating surrounding floodplain, on the 27th of September, prior to the peak of the event. **Right:** Flows spilling over bank into the Murray River from the floodplain, because of the high flows pushing through eastern regulators.

- Opening the Mary Ada regulator partially, even when flows are low (4,000ML/d) can very quickly deliver enough water to inundate all the low runners and floodplain between the regulator and the Edward River.

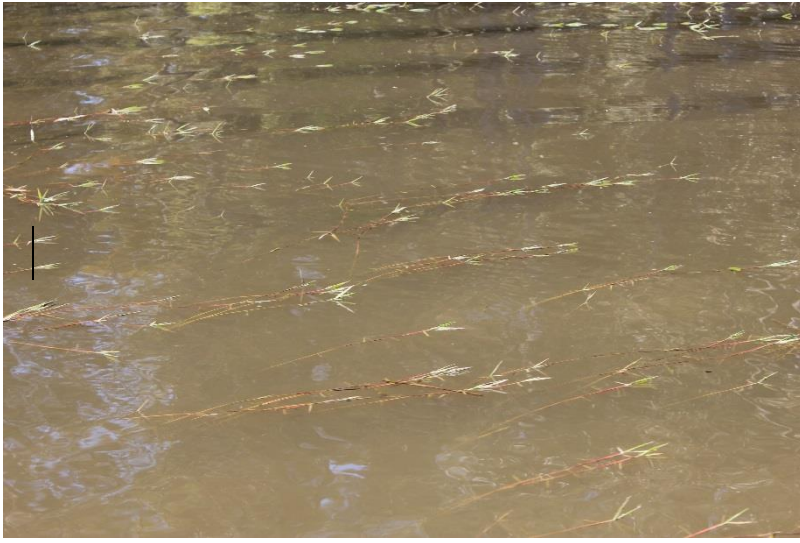
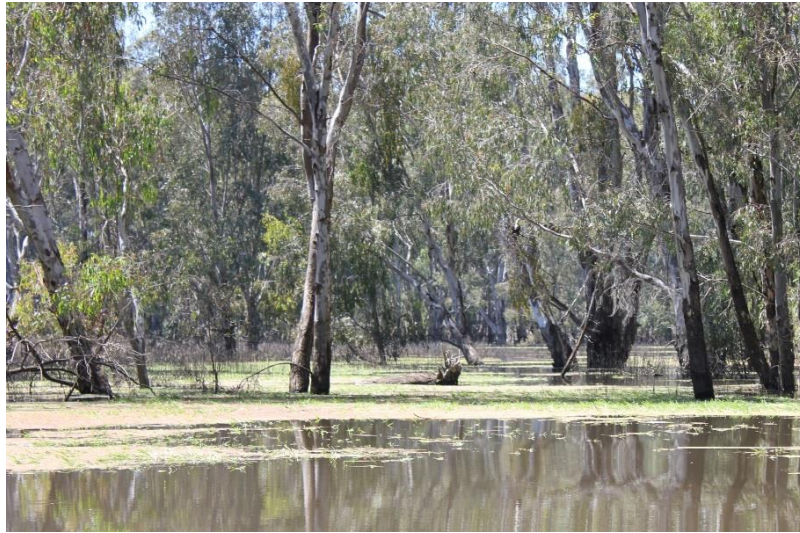
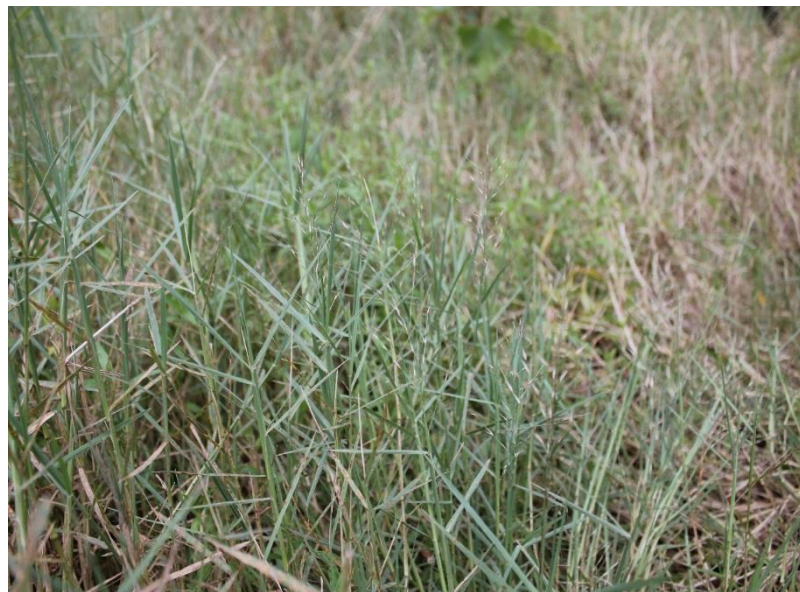
Figure 7: **Top:** Moira grass floating in deep water around Moira Lake (3/11/16); **Middle:** Moira grass swath SE Moira Lake (11/11/16); **Bottom:** Thatch of flowering Moira grass SE Moira

Moira grass was opportunistically monitored throughout the 2016-17 season. Access to the monitoring site used in previous years was limited. Moira grass was observed growing in the southern and eastern littoral zone of Moira Lake (Figure 7). This zone experienced depths of over 3 metres during the peak of the event, allowing Moira grass to achieve lengths over this height.

Widespread flowering of Moira grass was seen in Autumn, and a thick thatch of over 30cms. This could indicate low grazing pressure, perhaps the result of a reduction of kangaroos in the vicinity, post flood. A thick Moira grass thatch also provides habitat for a variety of small animals such as birds, frogs, lizards and snakes. It also allowed the grass to persist right into winter, promoting resilience heading into the next water year.

- Moira grass responded well to the deep-water levels and long duration of inundation experienced in Moira Lake. A thick, dry grass thatch remained present through to Winter, and will provide a good base for the grass to thrive in the next watering year.

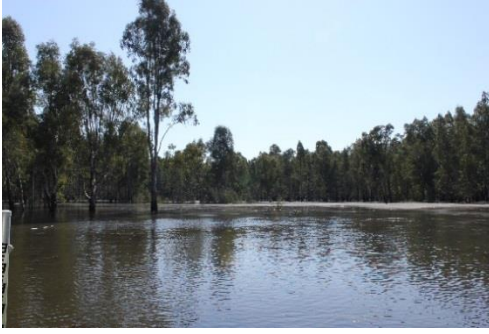
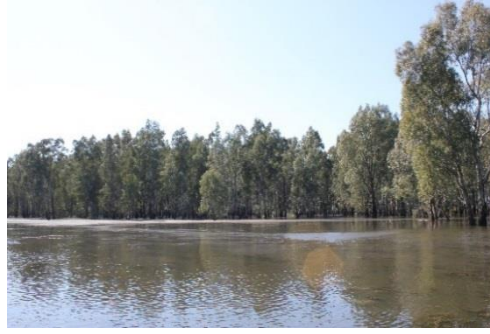
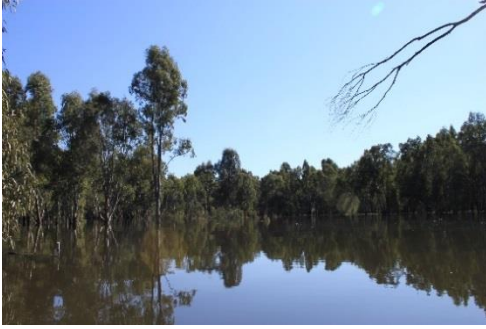
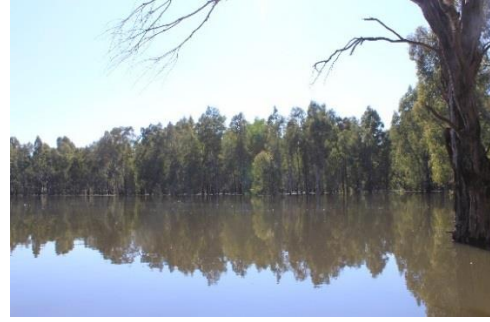
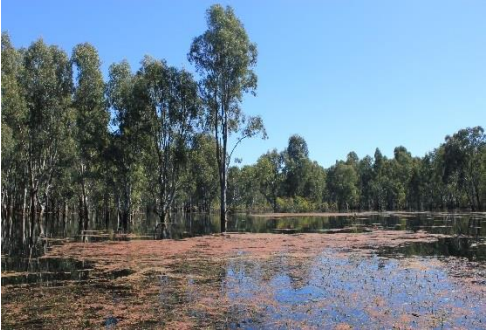
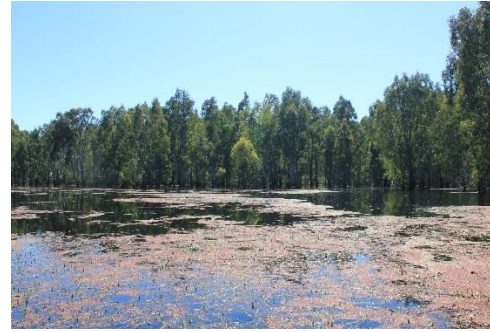
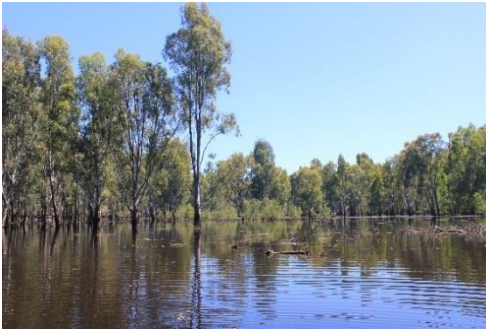
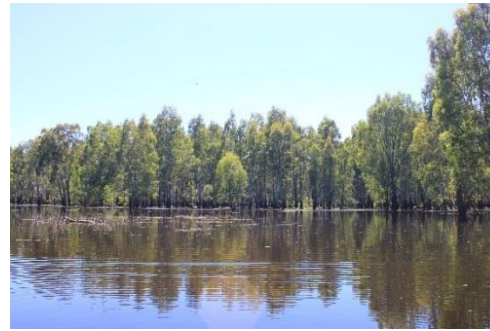
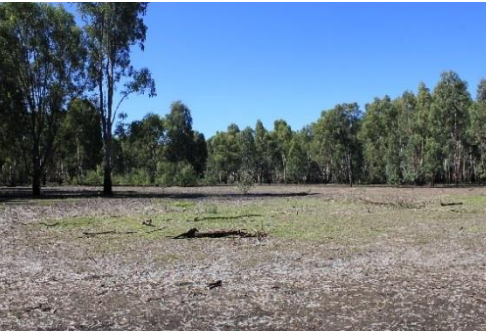
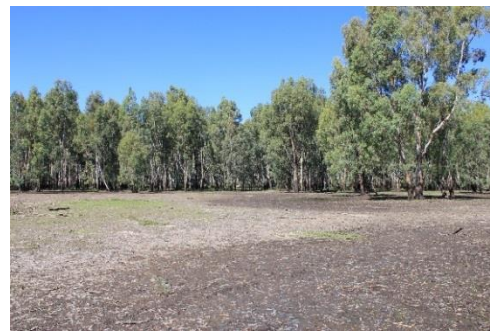
Porter's plain

Depths on Porter's Plain also exceeded 3 metres (Appendix A), however no Moira grass was observed. Aquatic vegetation that usually dominates the plain, such as *Myriophyllum* was observed to be not widely spread across the plain this year. This could be due to the cool temperatures and deep water. Historically, Moira grass would probably have been the species that thrived under these conditions, as seen at sites around Moira Lake. However, reduced inundation duration and depth, heavy cattle grazing and forestry practices appears to have eliminated it from the area.
