Intervention Monitoring Millewa Forest

2015-16

Report Title: Intervention Monitoring in Millewa Forest, 2015-16
Author: Ali Borrell and Rick Webster
South West Area
Parks & Wildlife Group
Report prepared for: The Living Murray Initiative
Front cover photo: Moira Grass on the eastern edge of Moira Lake, spring 2015 (Ali Borrell, NSW Parks)

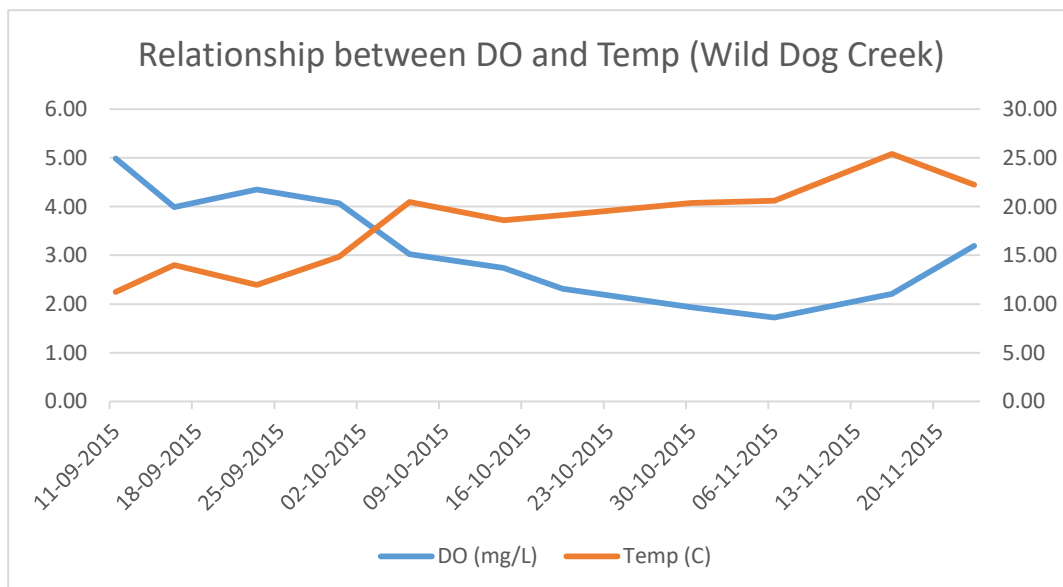
Figure 2: The relationship between dissolved oxygen levels and water temperatures recorded at Wild Dog Creek over the spring reporting period. Wild Dog creek is a prominent drainage line which discharges water from the floodplain of Millewa Forest, into the Edward River.

A drop in DO values occurred as water temperatures increased as demonstrated in Figure 2. The sites where low DO’s was recorded were discharging low volumes of water, posing a negligible risk as this water was diluted by much larger flows in Gulpa Creek, Edward and Murray Rivers. Although not measured, it is assumed that the return flows from the floodplain were providing a good source of DOC to these streams. The sites where larger volumes of water moved off the floodplain (Moira Lake and Gulpa Creek) maintained stable DO levels throughout the monitoring period, with decreases evident heading into mid-December. All values recorded over the monitoring period are presented in Appendix B.

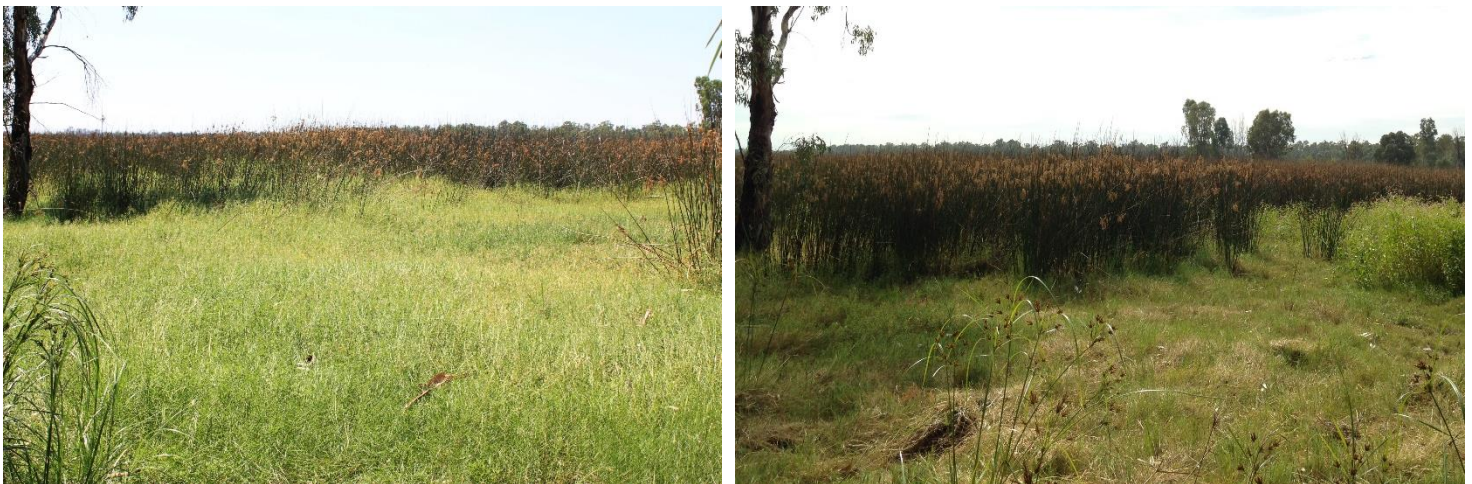
Figure 3: Moira grass monitoring site, on the south western edge of Moira Lake (03149181E/6019210N) Photo 1 (taken on 6 February 2014) and Photo 2 (taken on the 13th of March 2016).

The monitoring conducted involved recording the length of moira grass stems from randomly selected moira grass plants. The selected site exhibited a significant period of growth from October to November, as water temperature increased. Figure 3 shows a comparison of the site in February 2014 and in March 2016.

An increase in the extent of giant rush (*Juncus ingens*) can be seen in Figure 3 (photo 2), indicating increased encroachment over time. In 2014, the moira grass stand exhibits a much higher degree of uniformity (photo 1) than in 2016 (photo 2) and is also much longer. Photo 2 was taken slightly later in the year, which could account for the shorter length of plants as water levels drop and stems became desiccated. Decreasing water levels could also provide increased opportunities for grazing, as access for grazing animals (e.g. kangaroos) is improved. Also, differing watering regimes (the depth, duration of inundation, water temperature) could also account for the difference in the two photos by influencing the length of moira grass stems and its dominance in the ground layer. The conditions

(water regime) in 2016 may not have favoured moira grass. The presence of a number of other water-dependant/tolerant species such as water pepper (*Persicaria* sp.) and swamp wallaby grass (*Amphibromus* sp.) possibly indicates that the 2016 water regime was more favourable for these species than for moira grass (Figure 3).

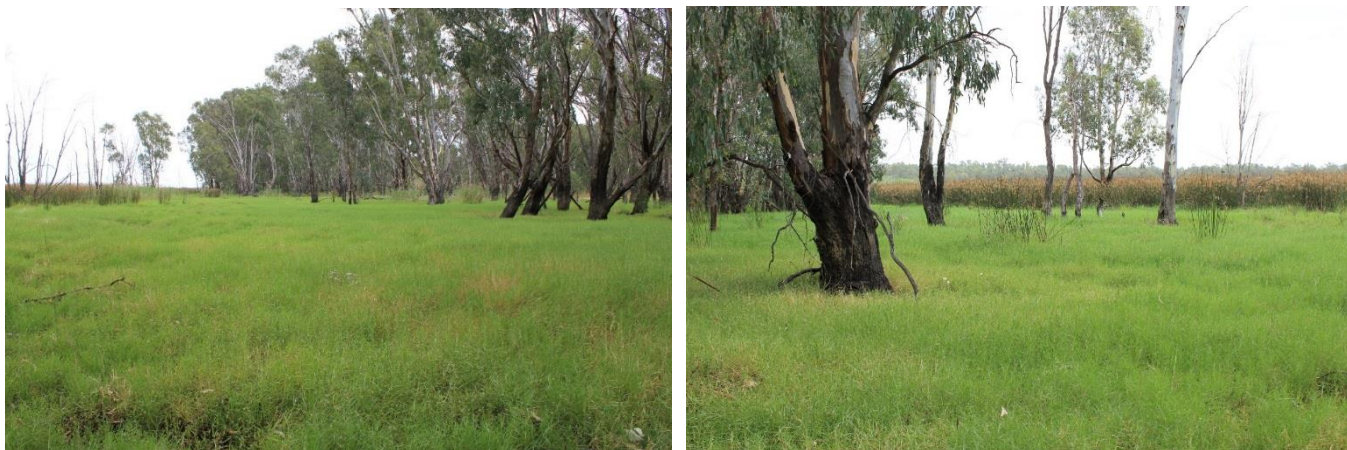
Figure 4: Moira grass on the eastern perimeter of Moira Lake (20/01/2016)

Varying conditions across wetlands may influence the growing regime of moira grass resulting different responses on the same wetland. A much more positive response was seen on the eastern side of Moira Lake. Here the moira grass stand was much more extensive, and uniform with good length (Figure 4). This could be attributed to a range of factors and could be linked to more optimal inundation period (better depth and duration), slower draw down period and a decreased grazing pressure. However flowering was also not evident at this site at the time of the site visit.

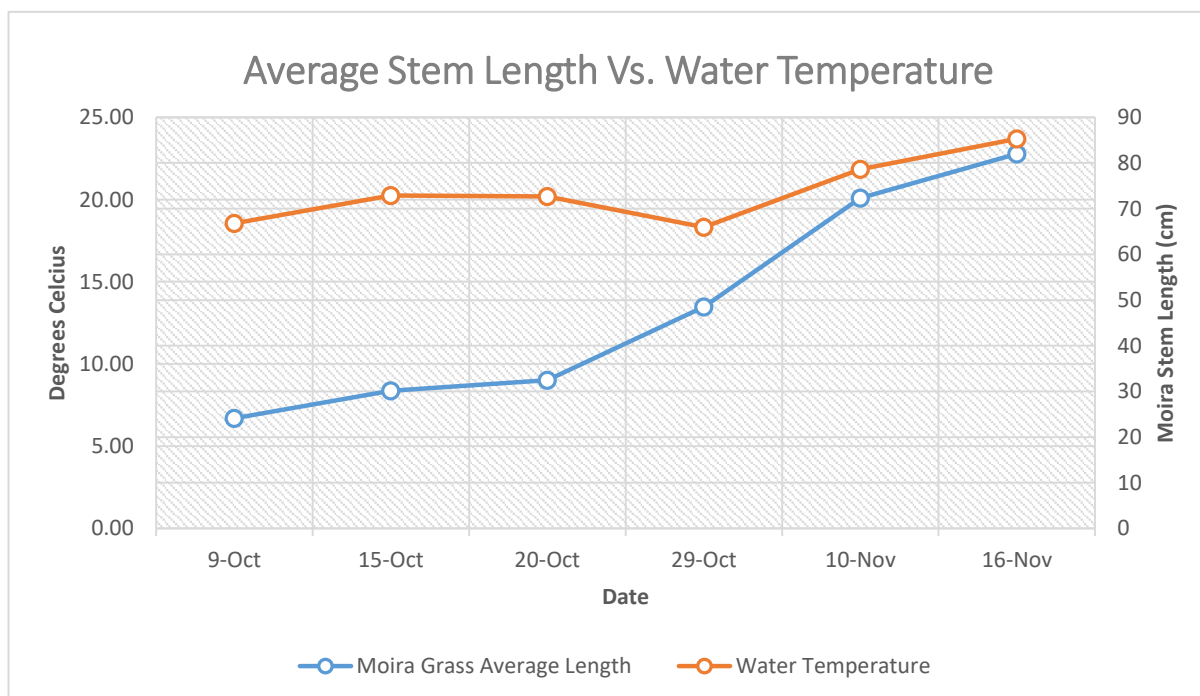
Figure 5: Average stem length over time of moira grass recorded on the southern western edge of Moira Lake, with recorded water temperature. As water temperature increased towards the end of November, there was a corresponding increase in Moira grass growth.

Figure 5 (above) shows the relationship between stem length and temperature for the moira grass measured in the monitoring site in Moira Lake. As water temperature increased in mid-November, an increase in moira grass stem length was also recorded. Ward (1991) showed that moira grass growth increased exponential throughout mid-October to mid-November. This may mean that trend of increased growth was not maintained at such a rate, after the period monitored. It can be seen in Figure 5, that with slightly higher temperatures in November, moira grass responded positively. Lengths of stems can be seen in **Table 1**.

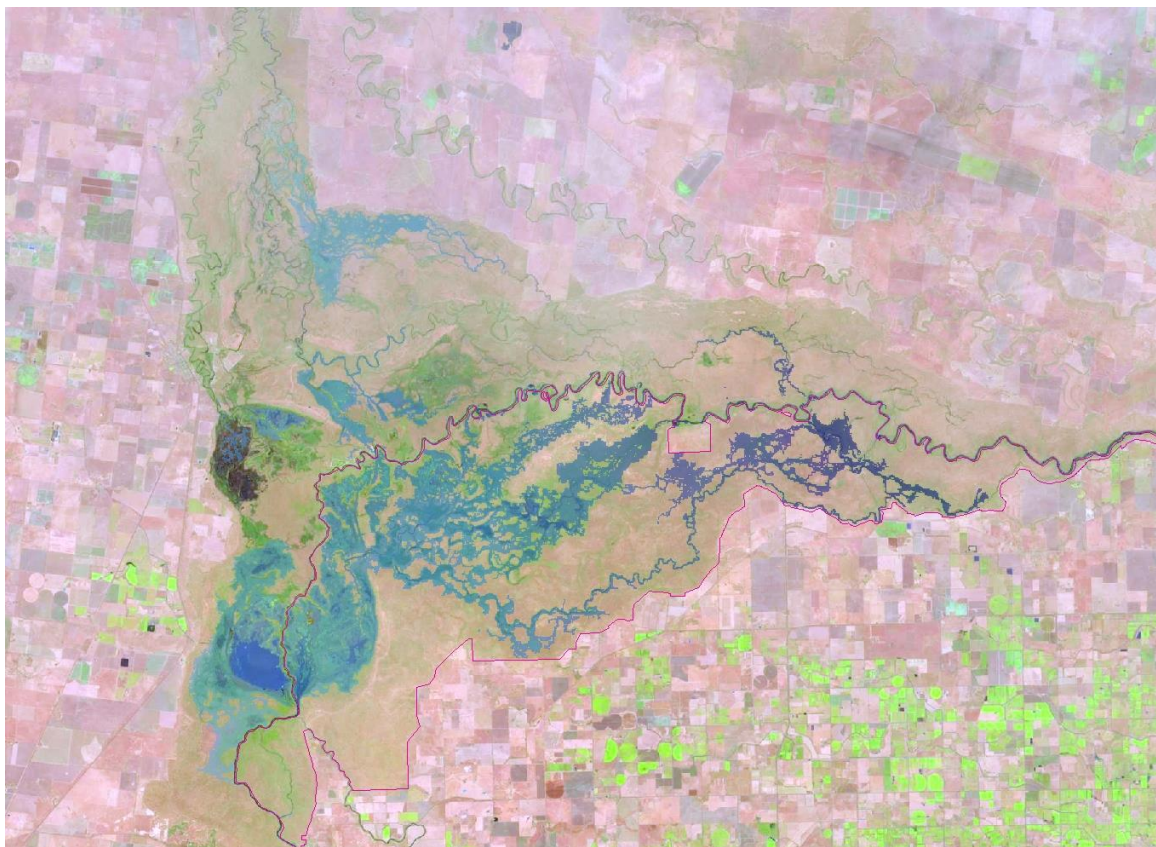
Figure 6: Modelled flows in Barmah-Millewa for the 2015/16 environmental watering event.

Figure 6 and Figure 7 show two different methods of mapping inundation in Barmah-Millewa forest. Over the period in which the images were attained, four of Millewa's regulators were open, including Mary Ada, Millewa's largest regulator delivering water into the forest. The Gulpa Creek had flows between 642ML/d and 851ML/d over this time resulting in overbank flows, and the Edward (at the offtake) ran from 1525 – 1625ML/d.

The MDBA modelling takes into account elevation, and uses inputs such as the gauge heights recorded in the forest and also regulator operations. Table 3 shows total areas (hectares) inundated across Barmah Millewa. This modelling shows water pushing out over the floodplain slowly in Millewa over the three months (after the peak of the flow had passed) and Barmah receiving more water across the floodplain early on in the event but receded quickly.

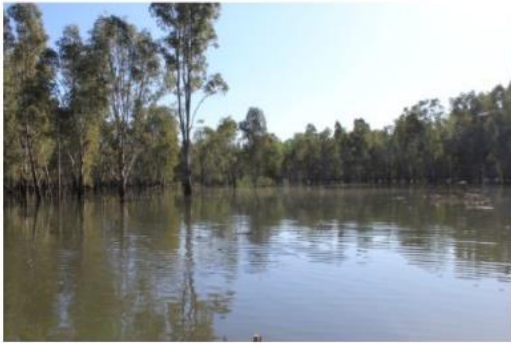
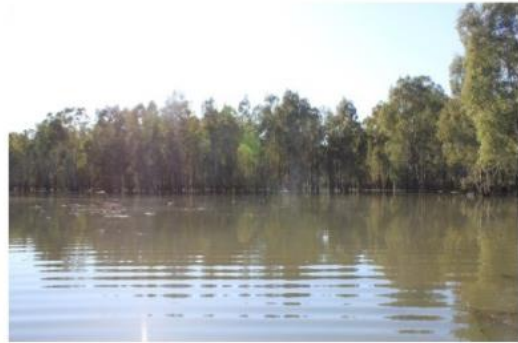
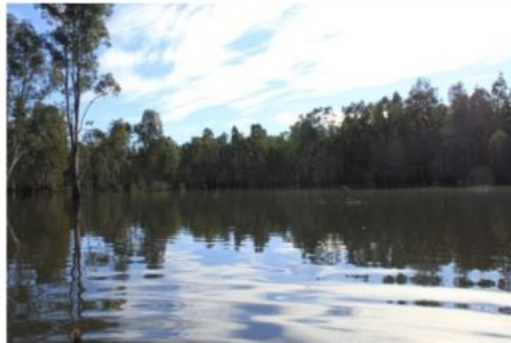
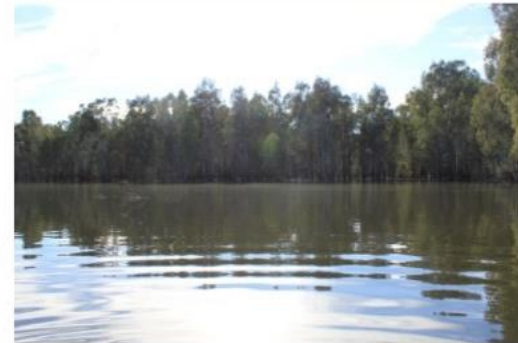
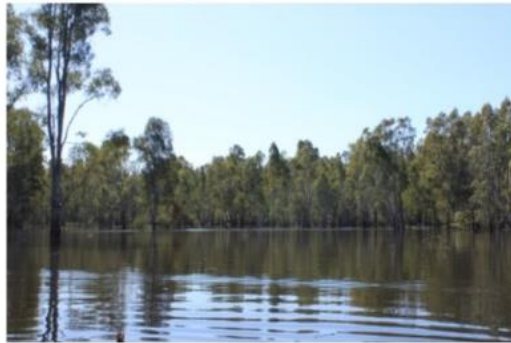
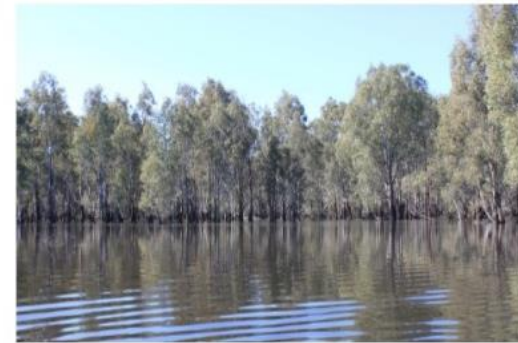
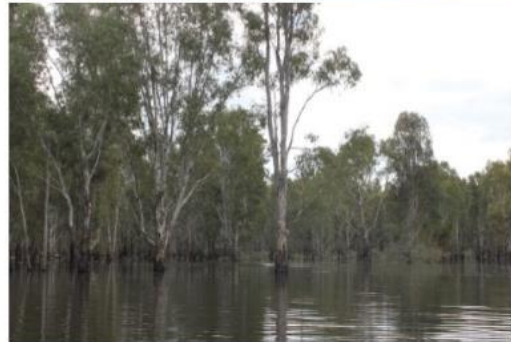
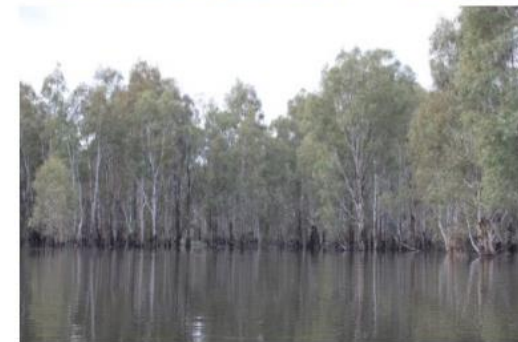
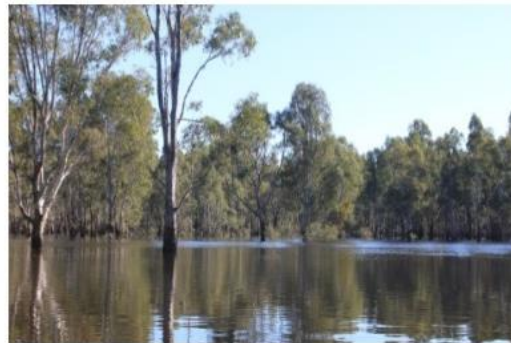
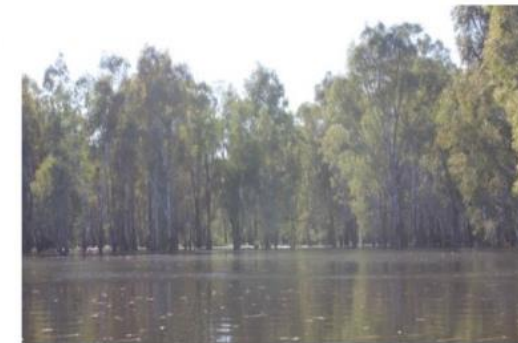
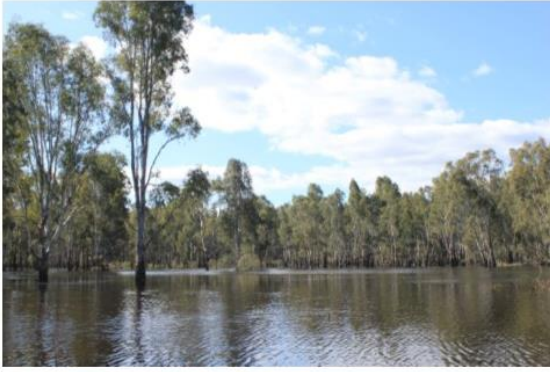
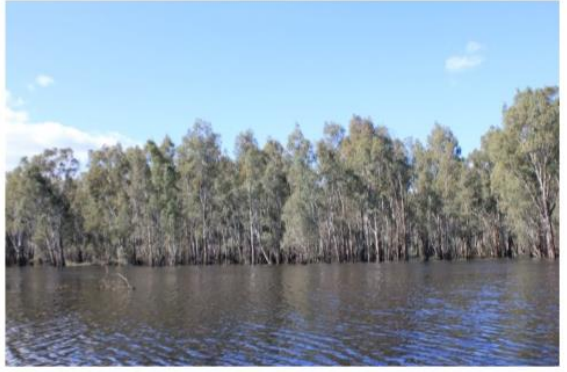
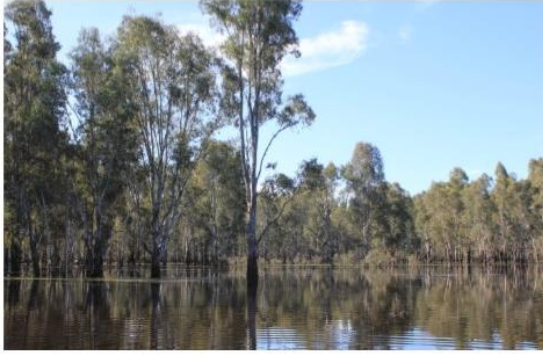
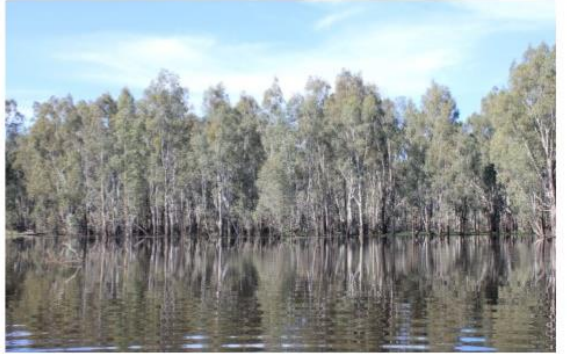
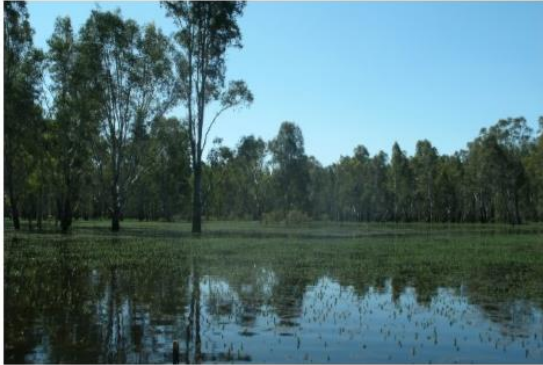
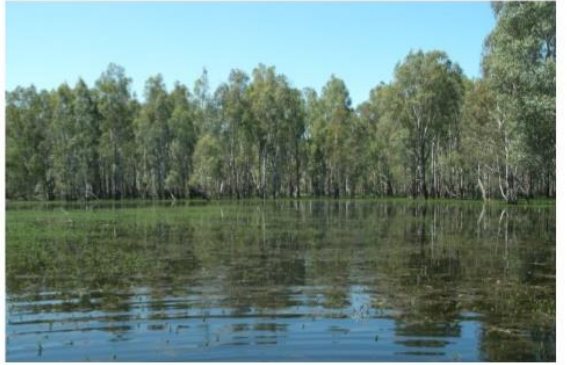
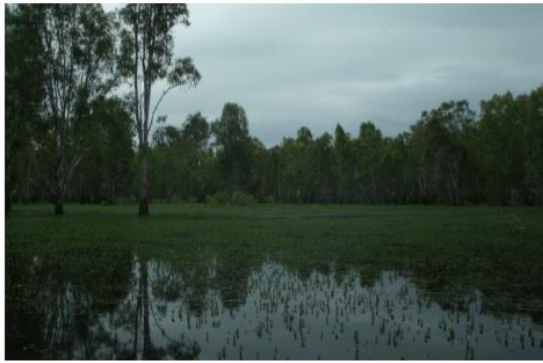
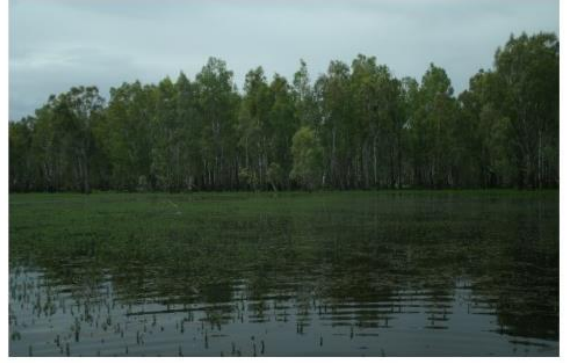
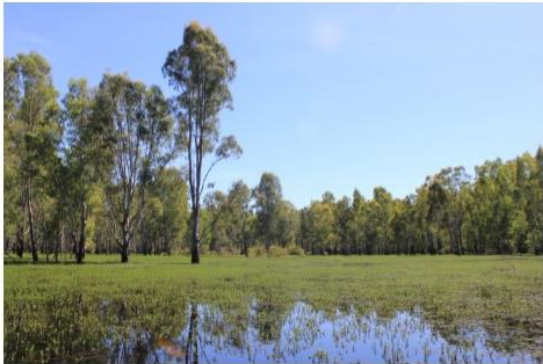
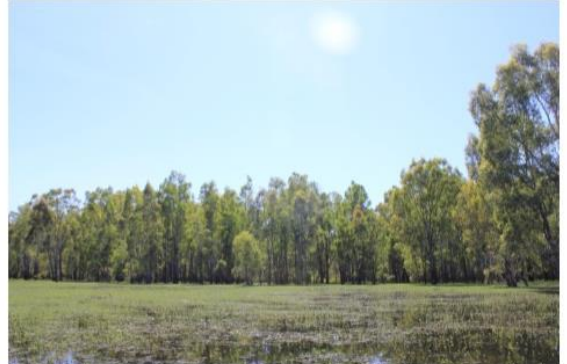
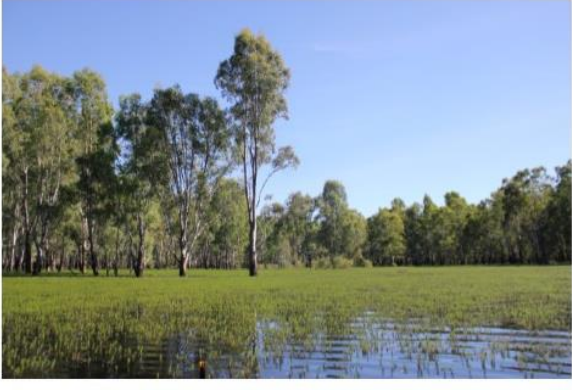
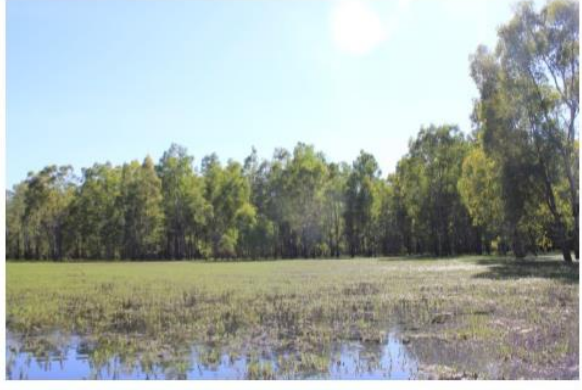
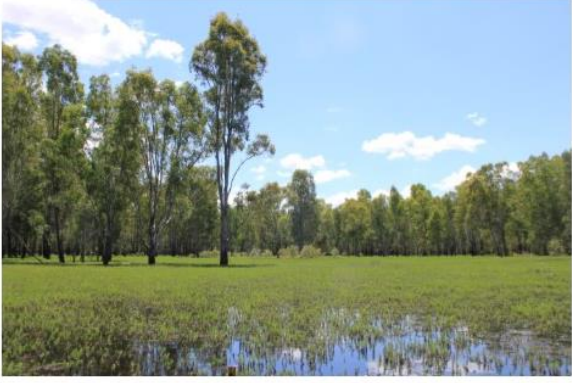
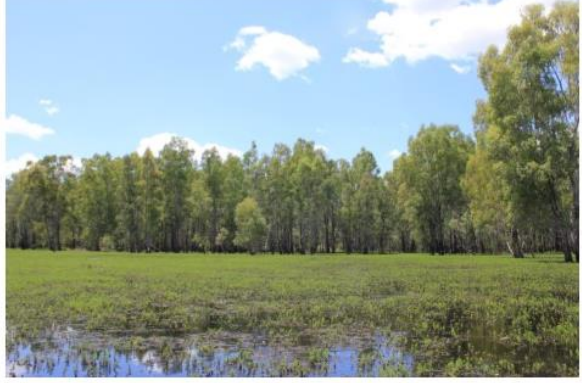
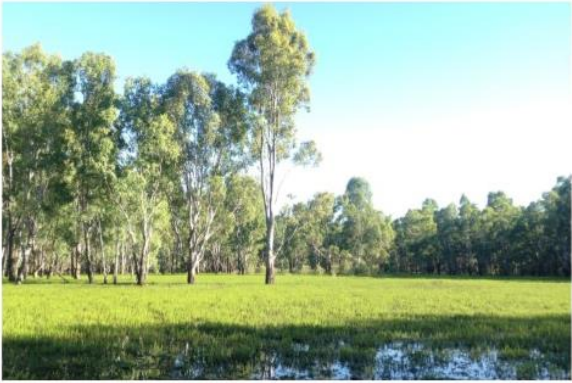
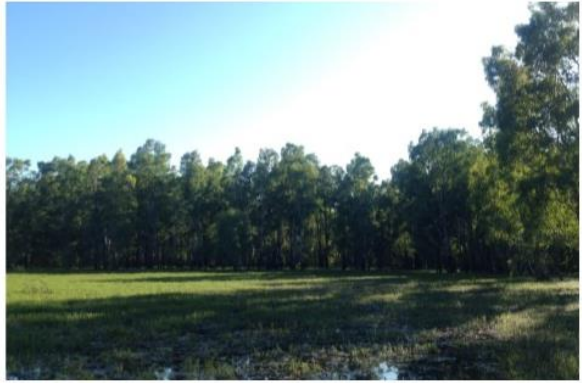
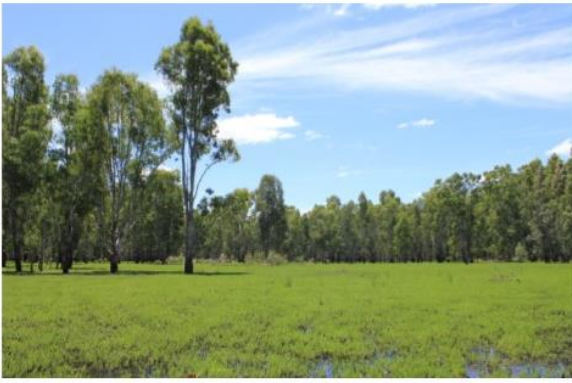
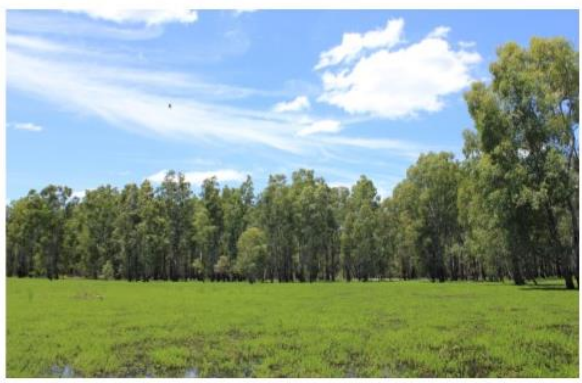
The sites selected for monitoring were Porter's Plain and Moira Lake. The Porter's Plain site was monitored throughout the event and site photos can be seen in Appendix C. No moira grass was found growing on Porter's plain this year. Open plains have reduced in area in Millewa over the last 40 years and moira grass has most likely been highly affected by this (Owen, 2013). However, due to river red gum encroachment, altered hydrology and previous heavy grazing, substantial stands of moira grass are no longer prevalent.
